ABSTRACT
WA-I-269
Martin Farm
Cearfoss Vicinity
private

MACI 中220年5535 INVENTORY FORM FOR STATE HISTORIC SITES SURVEY 578

1 NAME	<u> </u>				
HISTORIC					
AND/OR COMMON			·		
Martin Far	<u> </u>				
2 LOCATION	•		· ca	,	
STREET & NUMBER					
	oute 63, Greencastle-V	Villiamsport Pike			
CITY, TOWN			CONGRESSIONA	AL DISTRICT	
	<u>X</u>	VICINITY OF Cearfoss			•
STATE Maryland			COUNTY		
	A MI ON I		Washir	igton	
3 CLASSIFIC	ATION				
CATEGORY	0.445.50	•			
DISTRICT	OWNERSHIP	STATUS X_OCCUPIED	¥	PRESEN	
X_BUILDING(S)	PUBLIC X_PRIVATE	OCCUPIEDUNOCCUPIED	X_AGRICUL		MUSEUM
STRUCTURE	BOTH	WORK IN PROGRESS	COMMER		PARK
SITE	PUBLIC ACQUISITION	AĆĆEŚSIBLE	EDUCATIO		PRIVATE RESIDENC
_OBJECT	IN PROCESS	YES: RESTRICTED	ENTERTAI GOVERNA		RELIGIOUS SCIENTIFIC

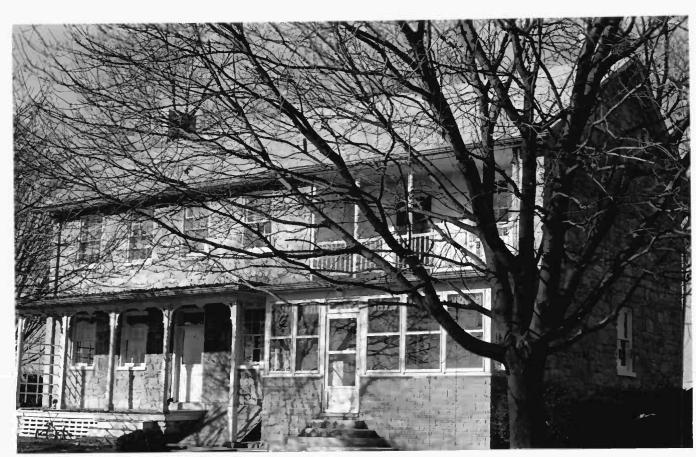
This rural building group consisting of a stone house and a frame bank barn dated 1911, is typical of many farms in the lower Cumberland Valley. Constructed of stone, a prominent building material in the area during the late 18th and early 19th centuries, the house with its recessed double porch along part of the front elevation is an example of an important local type with most such buildings dating from the middle third of the 19th century. The date of this house would appear to be consistent with other dated dwellings of the type in Washington County.
